# 738 Lodge & Shipley COMPANY

Subject: Twenty-third Monthly Progress Report (December 1 through December 31, 1962) on Contract No. DA-33-008-ORD-2084; Magnesium Alloy Airframe; Project No. TN2-8106; OMS Code 5210.11.142; Department of the Army Project No. 512-15-023  
OMS Code; 5010.11.14200.19  
5010.11.14200.35

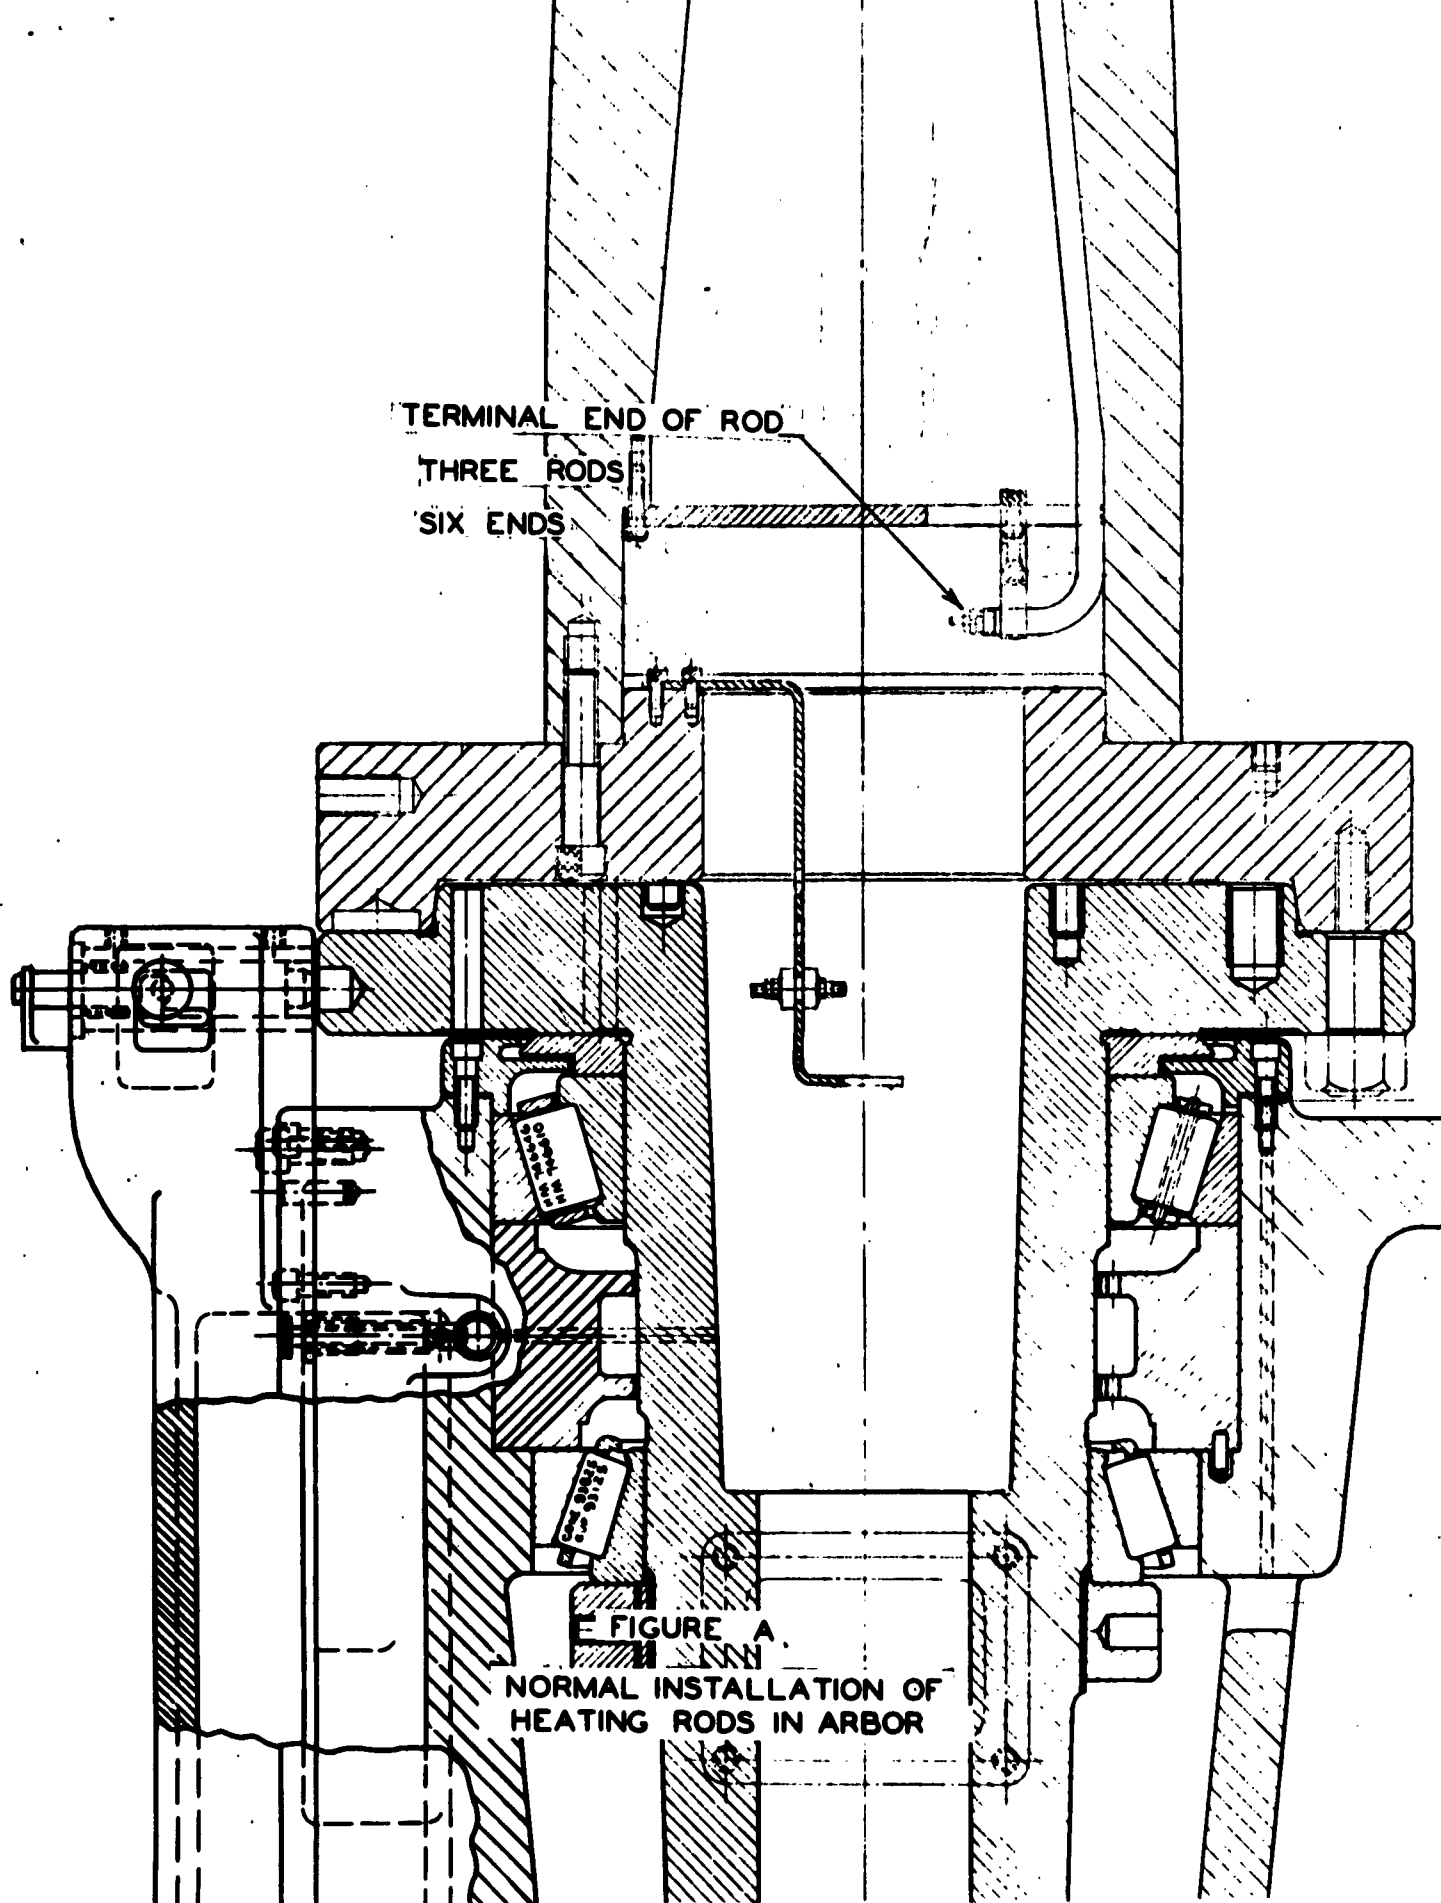
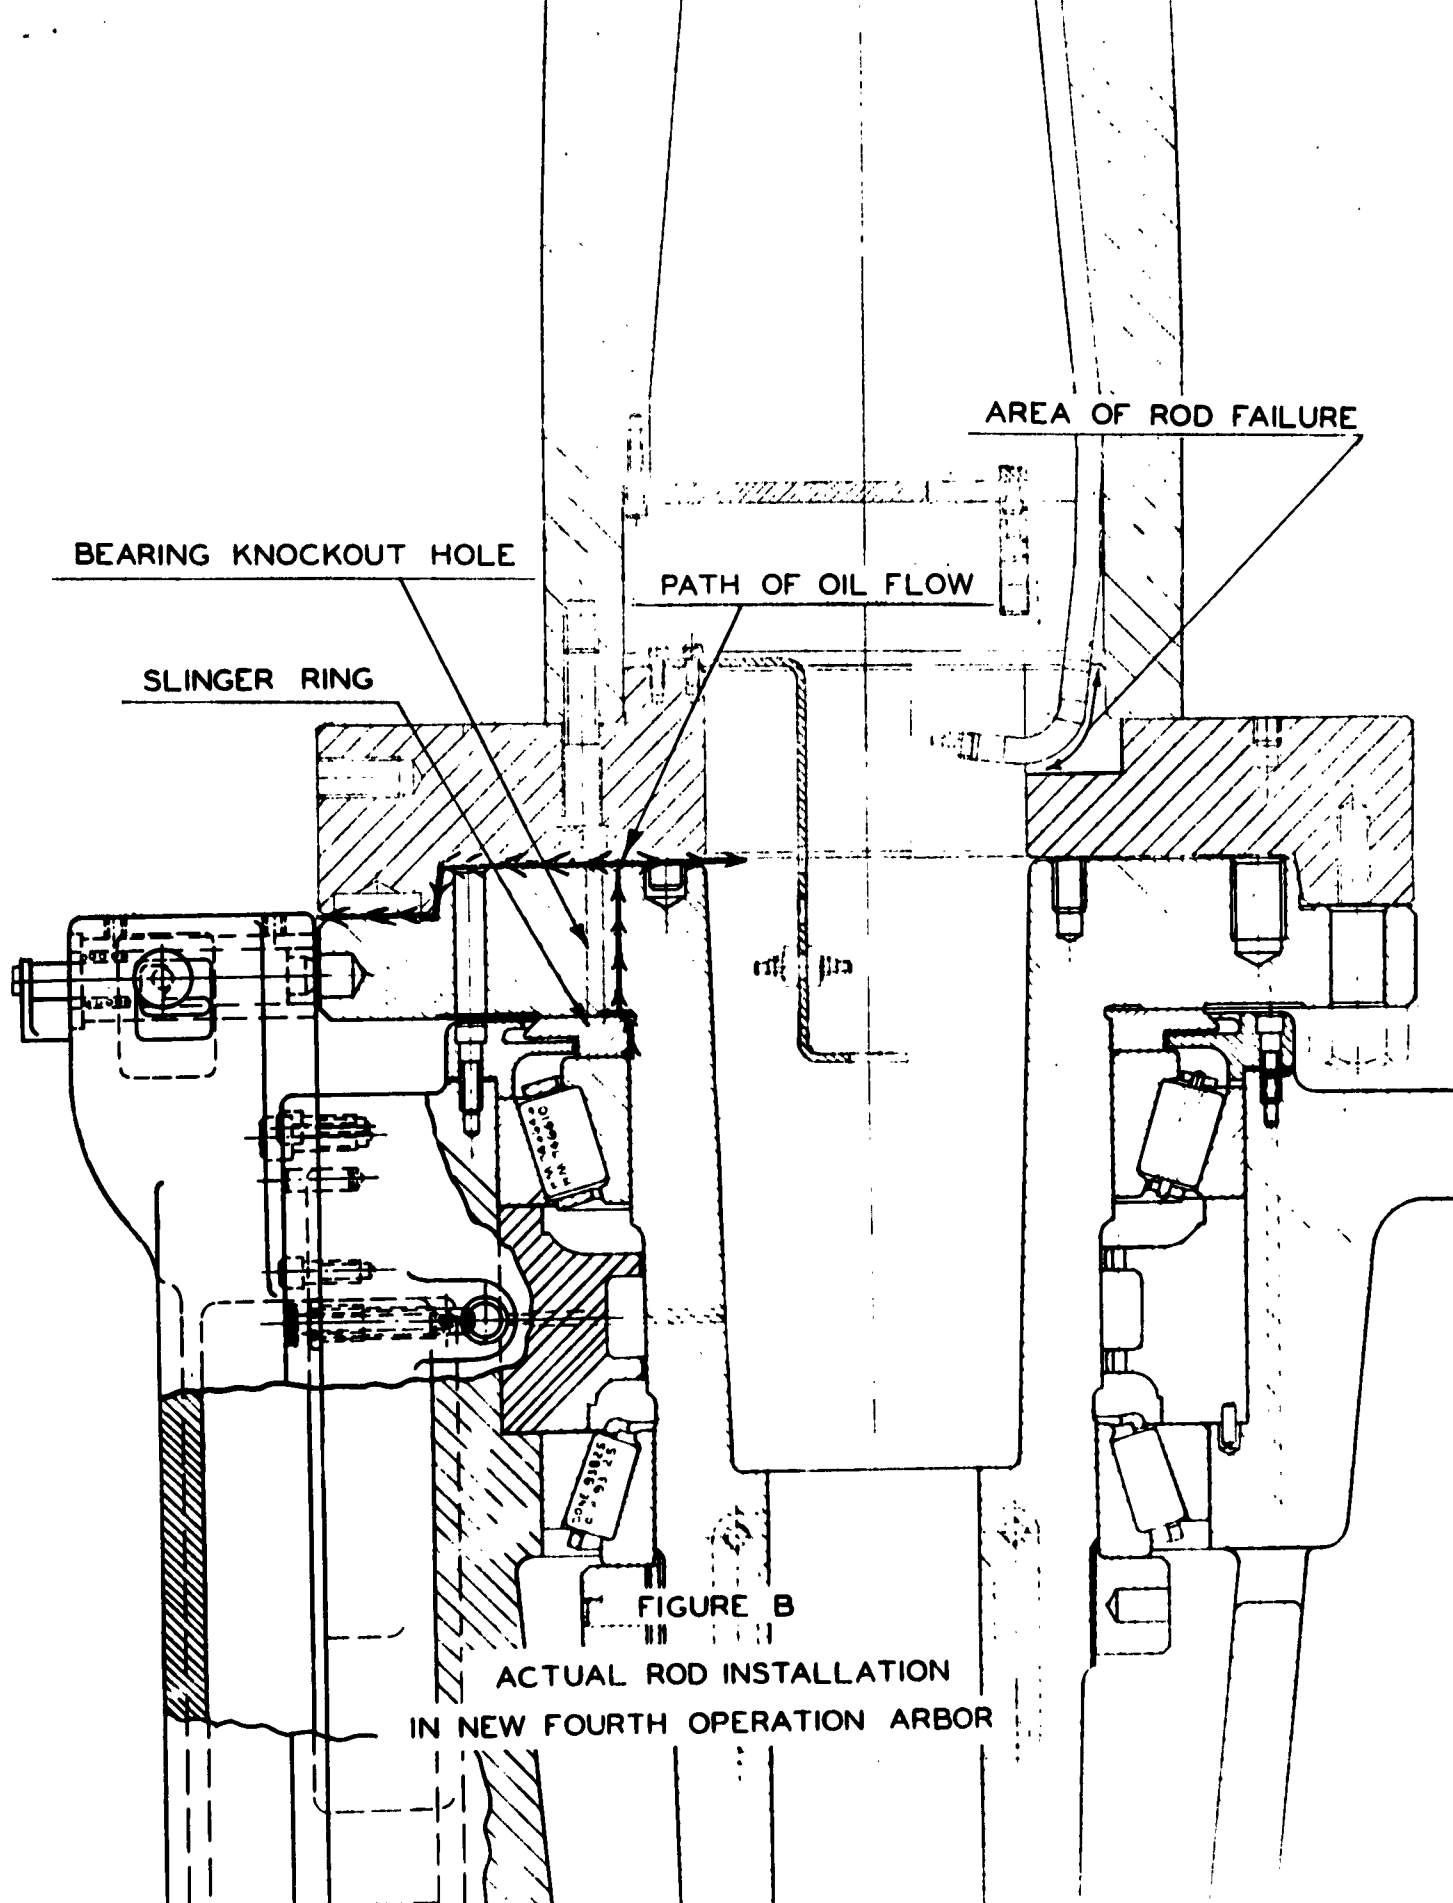
On December 26th, the adapter was removed from the arbor and it was found that the alloy sheath of all three rods was burnt through at one end approximately three inches from the end terminal. Also, all surfaces of the arbor, adapter and rods in the cavity at the large end were coated with a brownish white film that is the characteristic result of vaporized oil.

Figure A shows the normal installation of the heating rods in the arbor. The position of the end of the rod shown is the designed and actual location the rods in the first, second, third and original fourth operation arbors.

Figure B shows the position of the ends of the heating rods in the new fourth operation arbor. Difficulties encountered with the long, slender core when casting tool steel resulted in the rods extending approximately three inches beyond the correct position. Six slots were milled in the adapter to provide clearance for the rods.

Since the rods were closer to the spindle, a greater heat flow into the spindle was encountered which caused some distortion of the spindle and slinger ring permitting oil to flow out through the bearing knockout holes into the space between the spindle and the arbor adapter. This oil reached the terminal ends of the rods and was absorbed by the Magnesium Oxide insulation in the rods until the oil reached the Nichrome resistor were causing rapid failure of the wire and alloy sheath.
